Living Shoreline Design Guidelines for Shore Protection in Virginia's Estuarine Environments

Version 2.0

***Special Report in Applied Marine Science and
Ocean Engineering #463***

September 2017

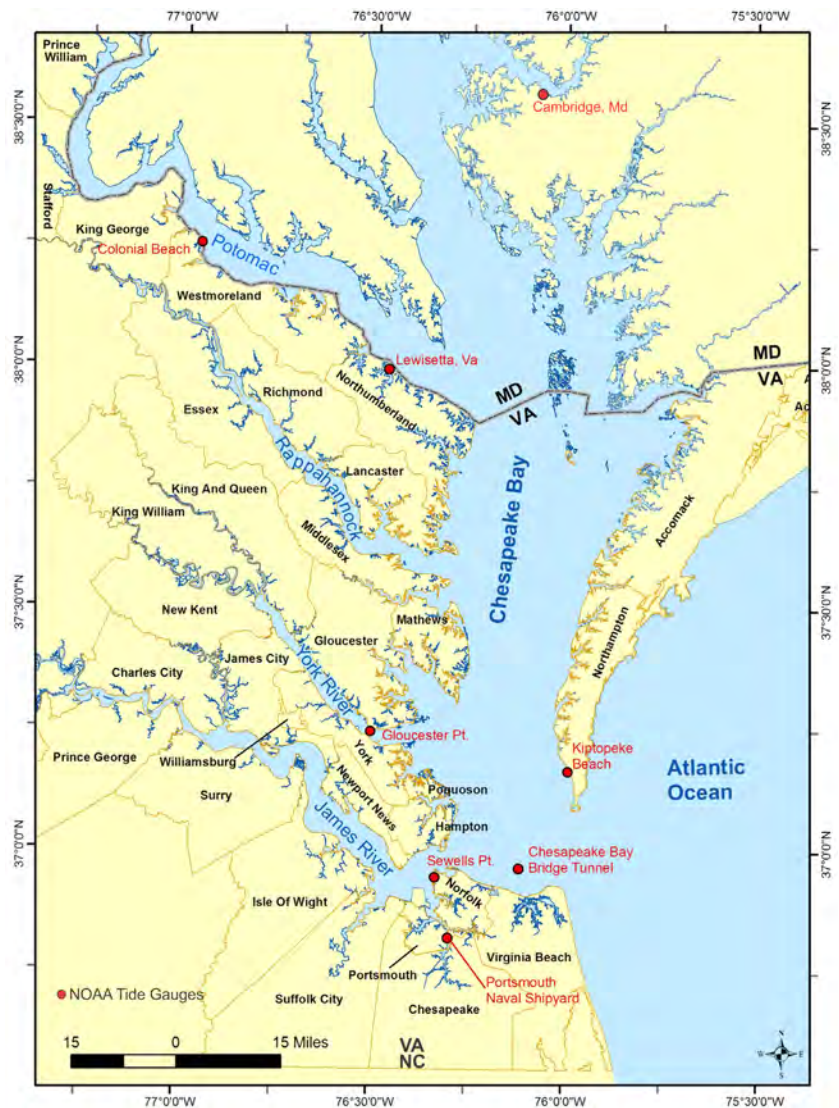
Figure 1-1. Virginia portion of the Chesapeake Bay estuary and location of tide gauges.

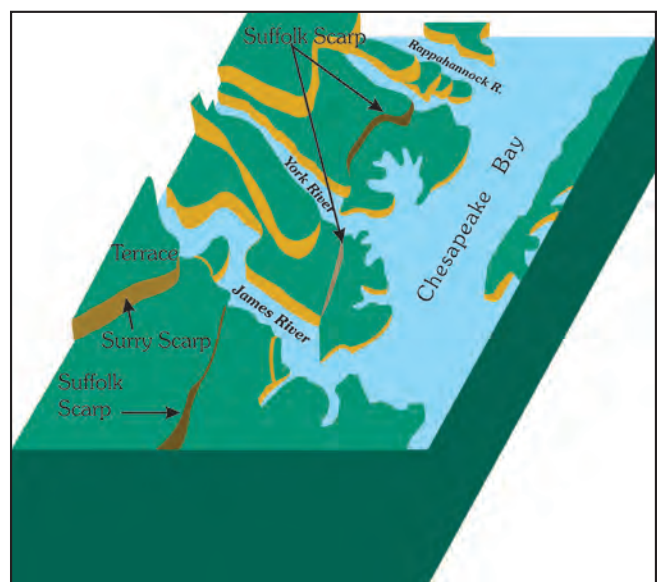
Figure 1-2. Ancient scarp features of the Virginia Coastal Plain (after Peebles, 1984 from Hardaway and Byrne 1999).

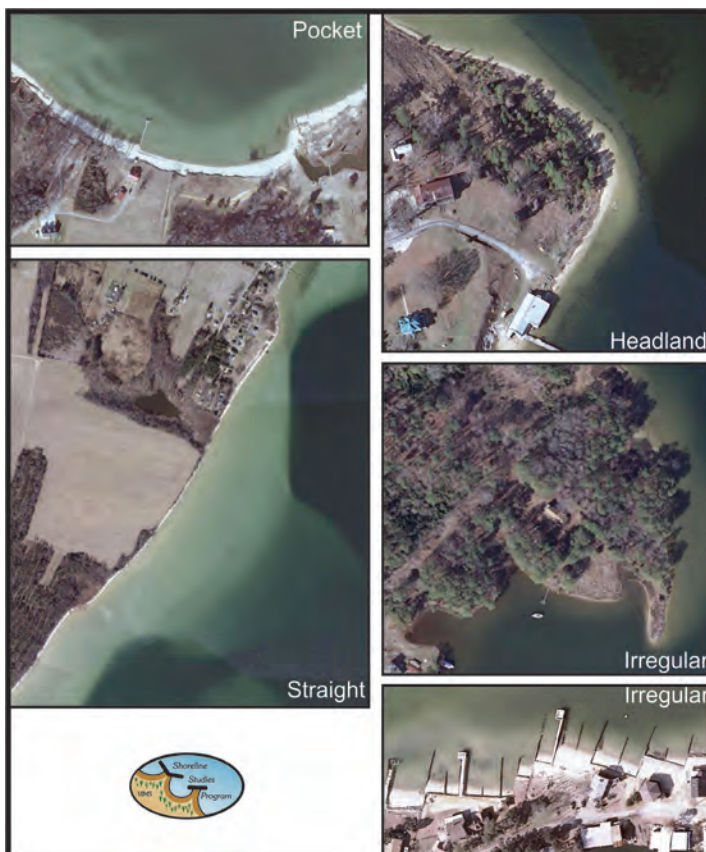
Figure 2-2. Photos illustrating four different types of shore morphology within Chesapeake Bay. Photos: VGIN 2009.

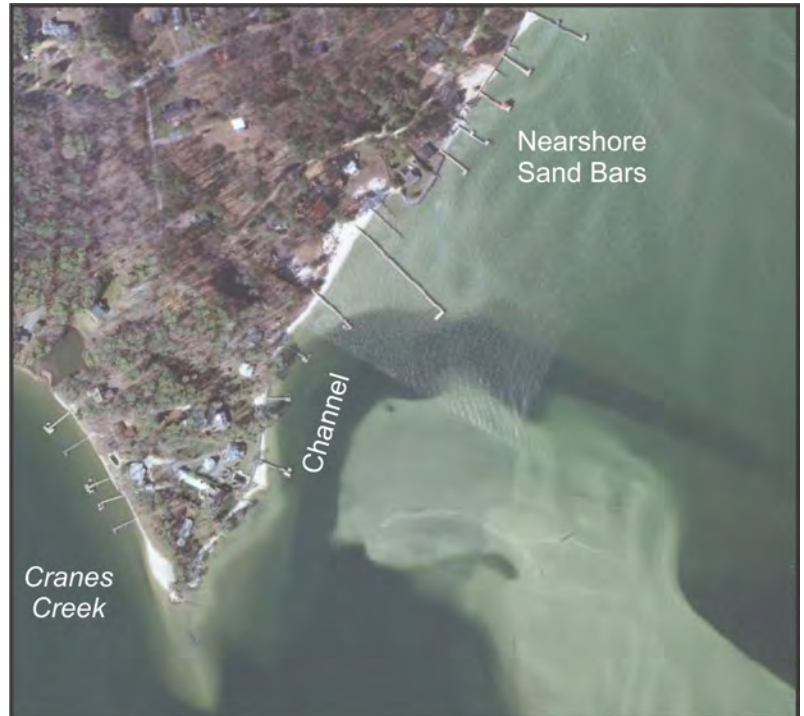
Figure 2-4. A VGIN 2009 photo shows the channel into Cranes Creek in Northumberland County, Virginia. Sand bars north of the channel will attenuate waves while the shoreline adjacent to the channel has no bars and will feel the full effect of the waves impacting the shoreline.

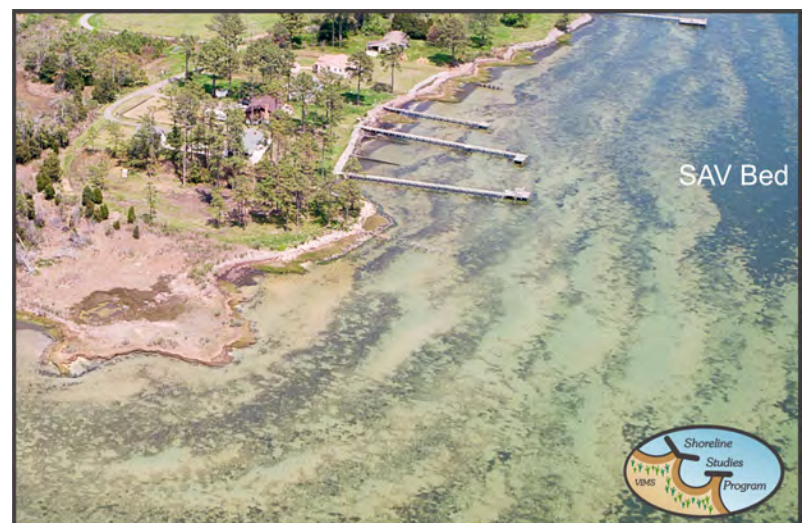
Figure 2-5. A VIMS aerial photo of Pond Point on the East River in Mathews, Virginia (dated 21 April 2009) showing extensive SAV in the nearshore, as well as sand bars.

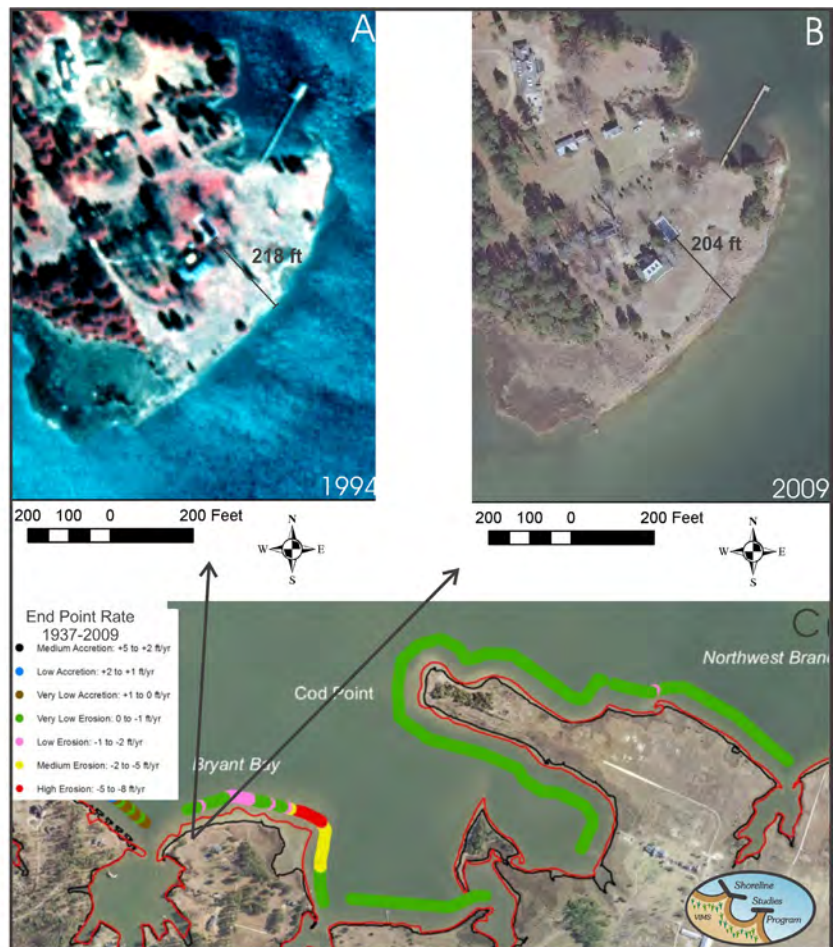
Figure 2-7. Determining rate of change along the shoreline. Aerial photos of a site in Gloucester County in A) 1994 and B) 2009. C) The end point rate of shoreline change determined between 1937 and 2009. Rates are visualized as different colored dots and show the variability of rates of change along small sections of shore (from Milligan *et al.*, 2010).

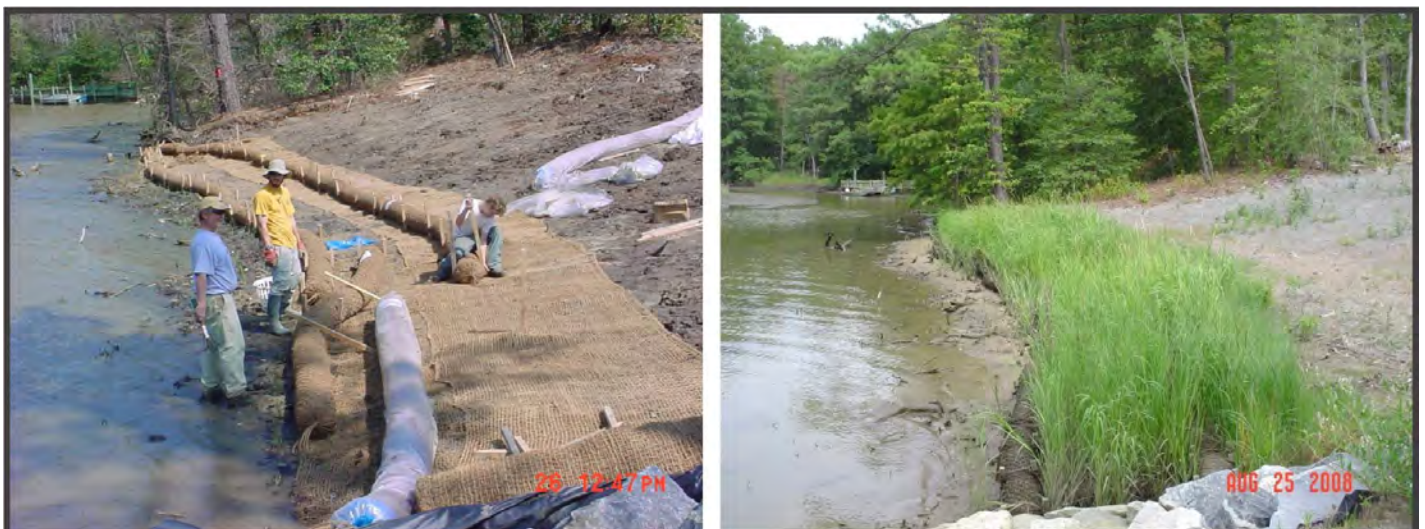
Figure 3-2. Coir logs and mats placed at toe of a graded bank for temporary stabilization while planted tidal marsh and riparian buffer become established. Photos by P. Menichino.

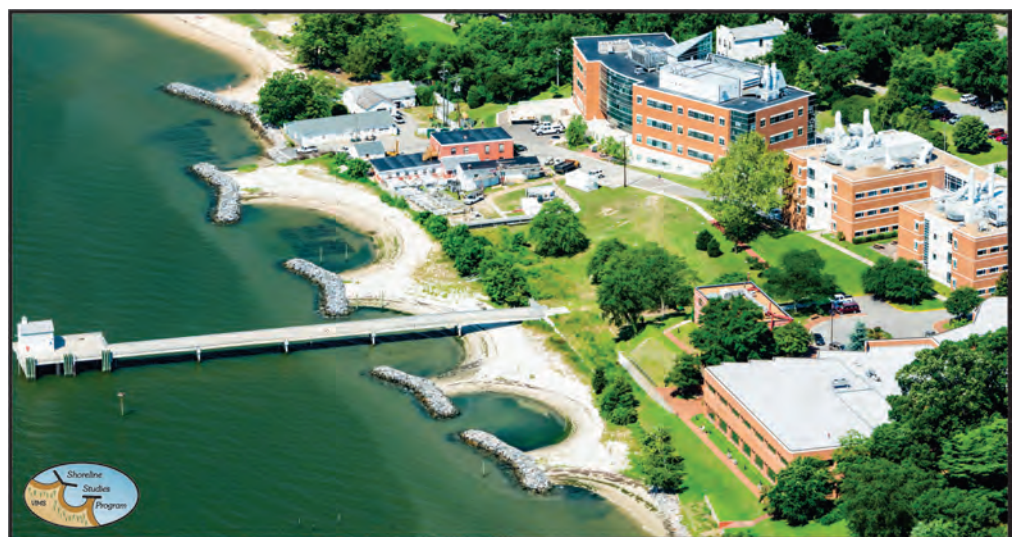
Figure 3-6. Aerial photo of breakwaters at the Virginia Institute of Marine Science campus on the York River. While the physical characteristics of breakwater sites differ, the goals are the same: protect the upland bank/marsh with a wide recreational/protective beach.

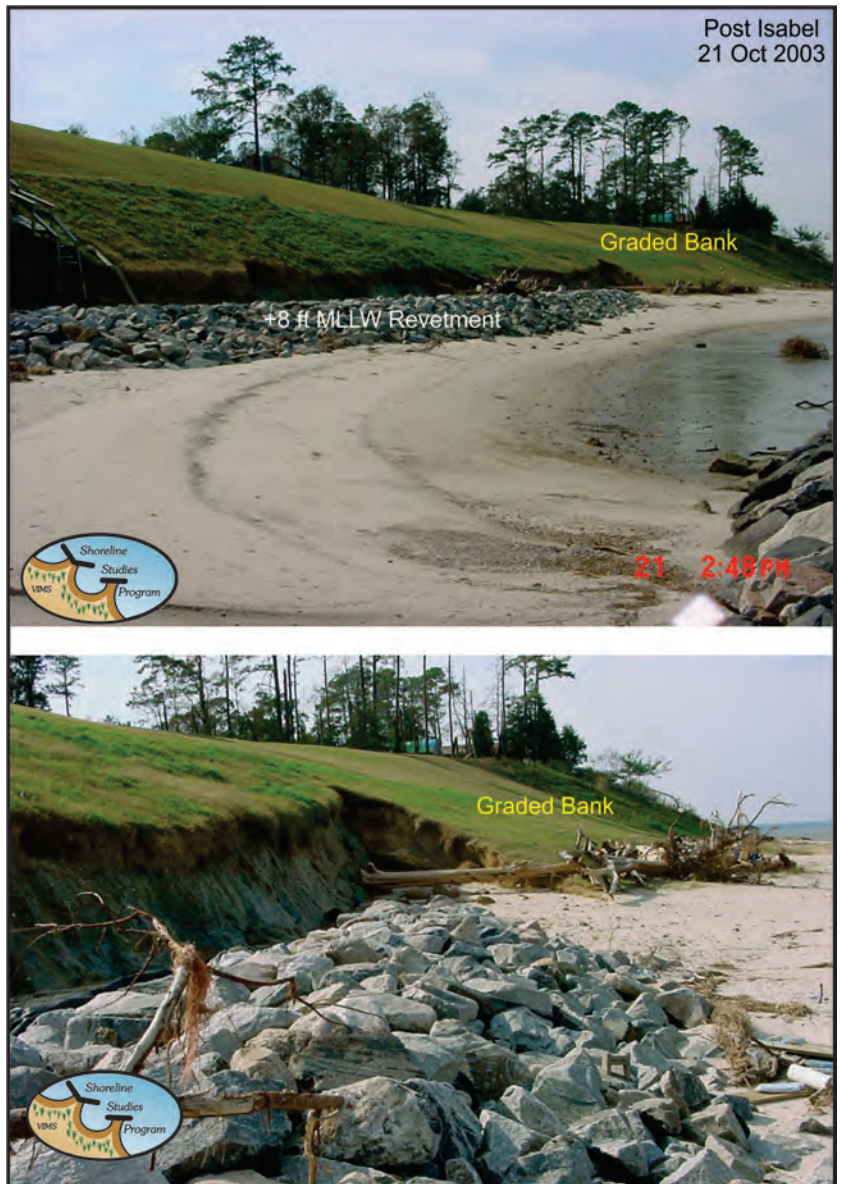
Figure 3-9. Revetment on the James River that was overtopped by storm surge and waves during Hurricane Isabel. Photo dates 21 October 2003.

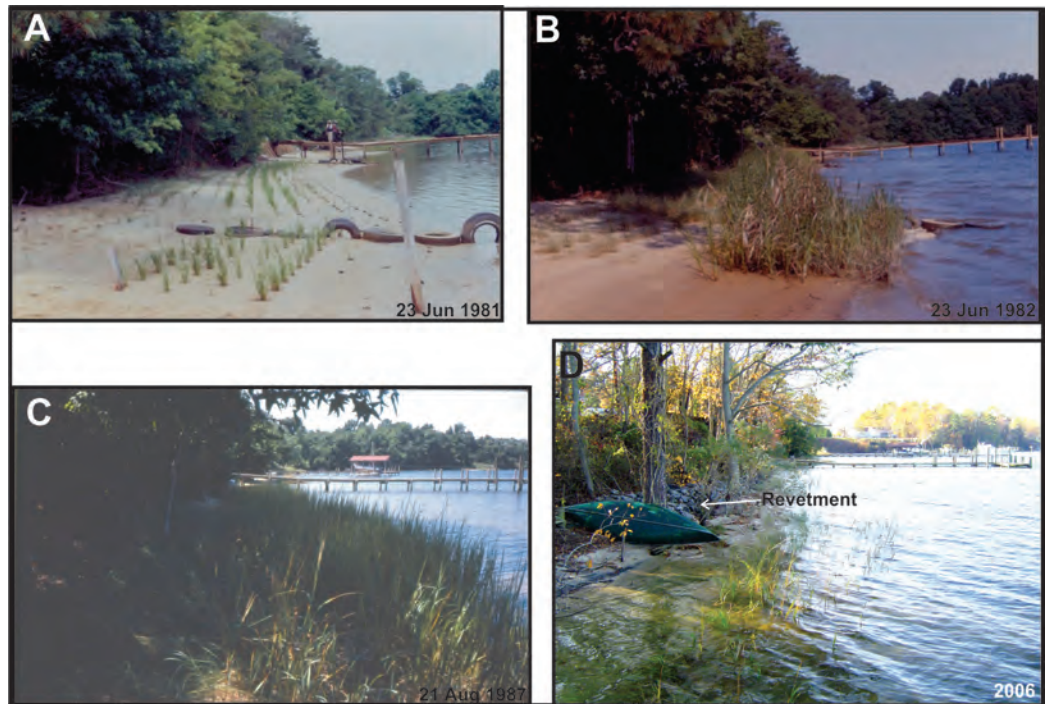
Figure 4-1. Lee marsh management site A) just after installation, B) a year later, C) six years after installation, and D) 25 years after construction.

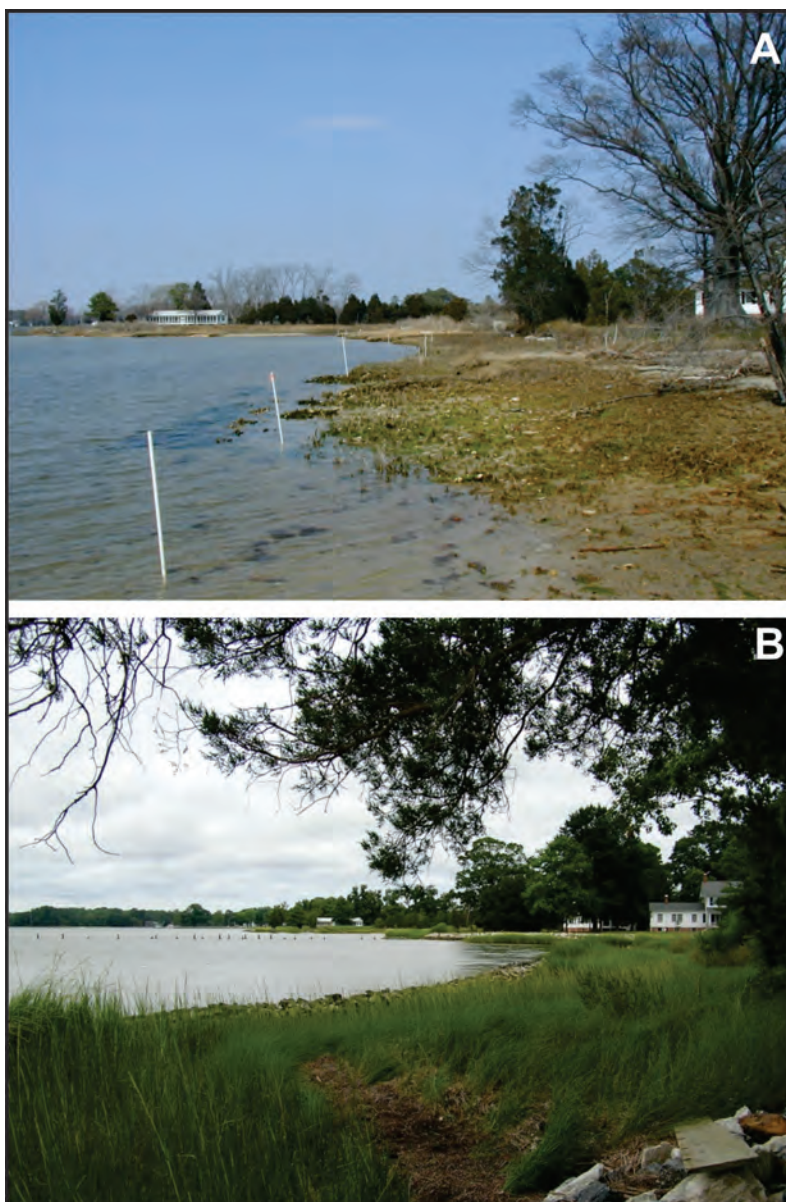
Figure 4-2. Hollerith marsh toe revetment/sill site A) before project with eroding fringing marsh in winter and B) after construction.

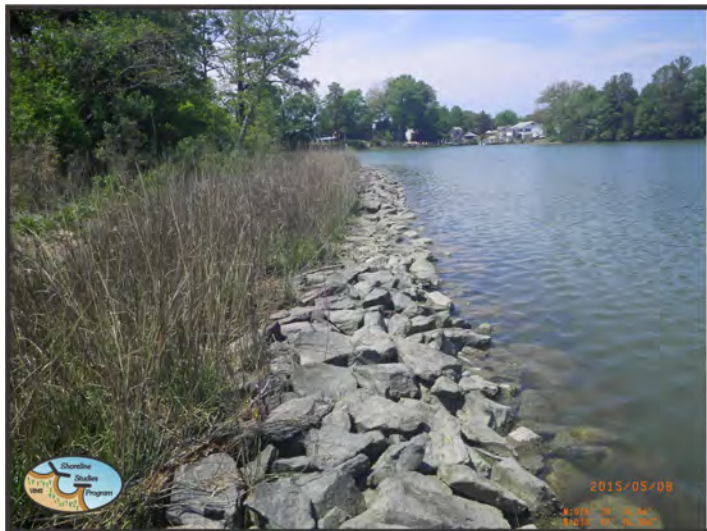
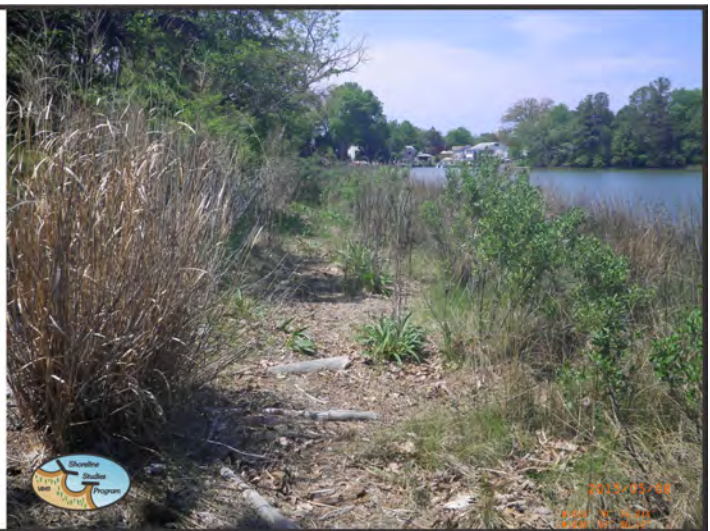
Figure 4-10. Photos of Hull Springs Farm in May 2015, seven years after construction.

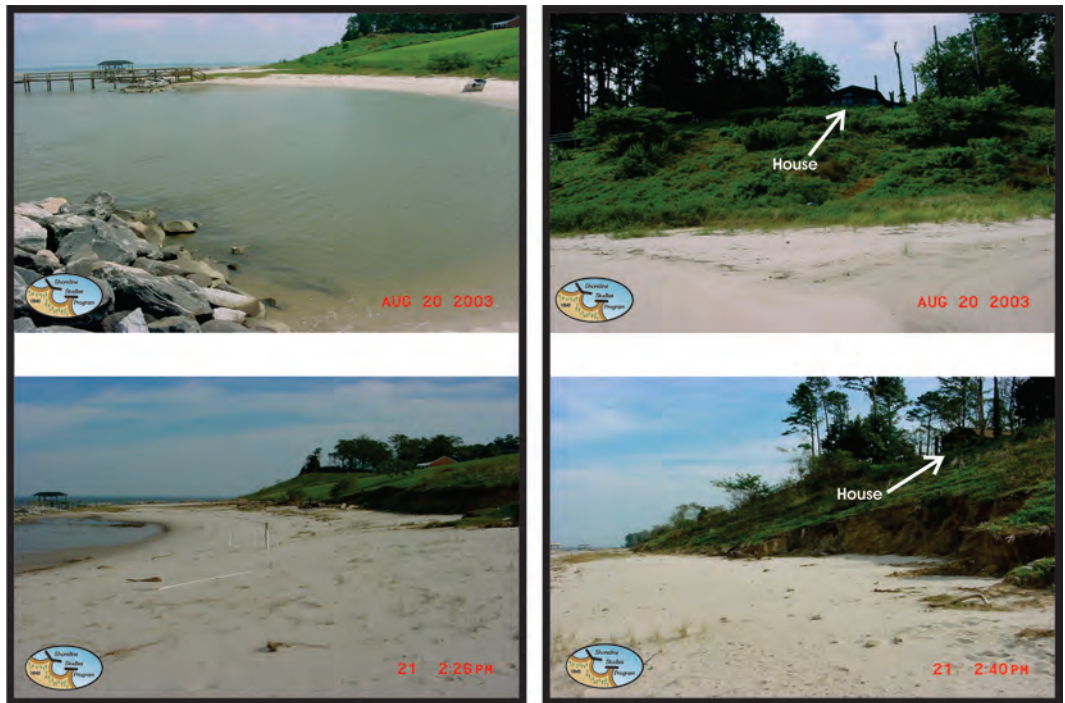
Figure 4-12. Van Dyke ground photos before (top) and after (bottom) Hurricane Isabel (from Hardaway et al., 2005).

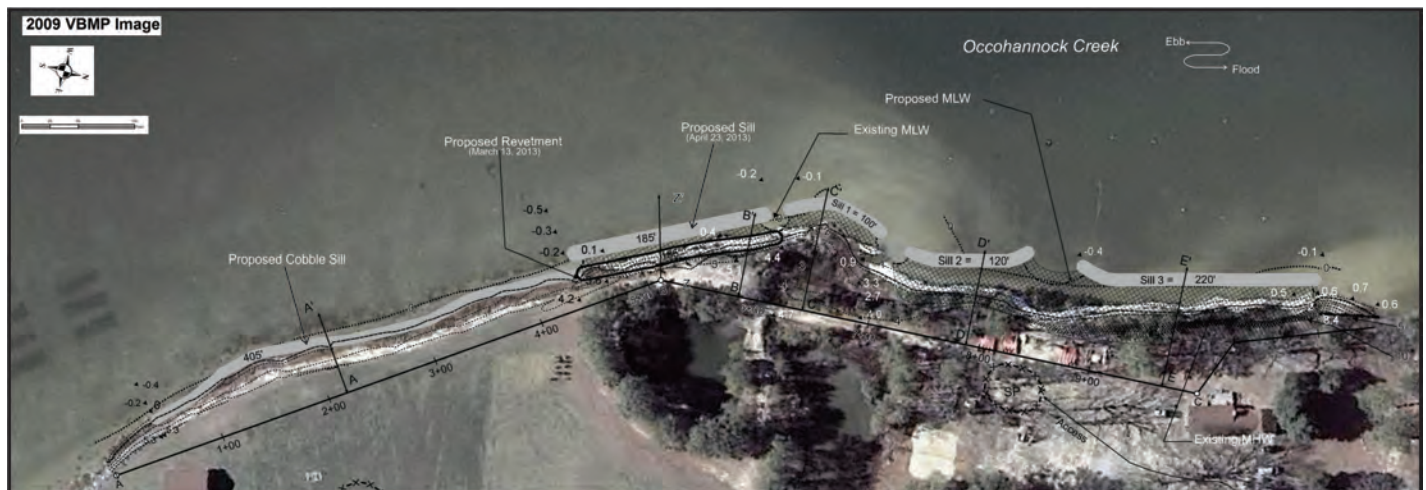
Figure 5-3. Design for shore structures at Occohannock on the Bay.

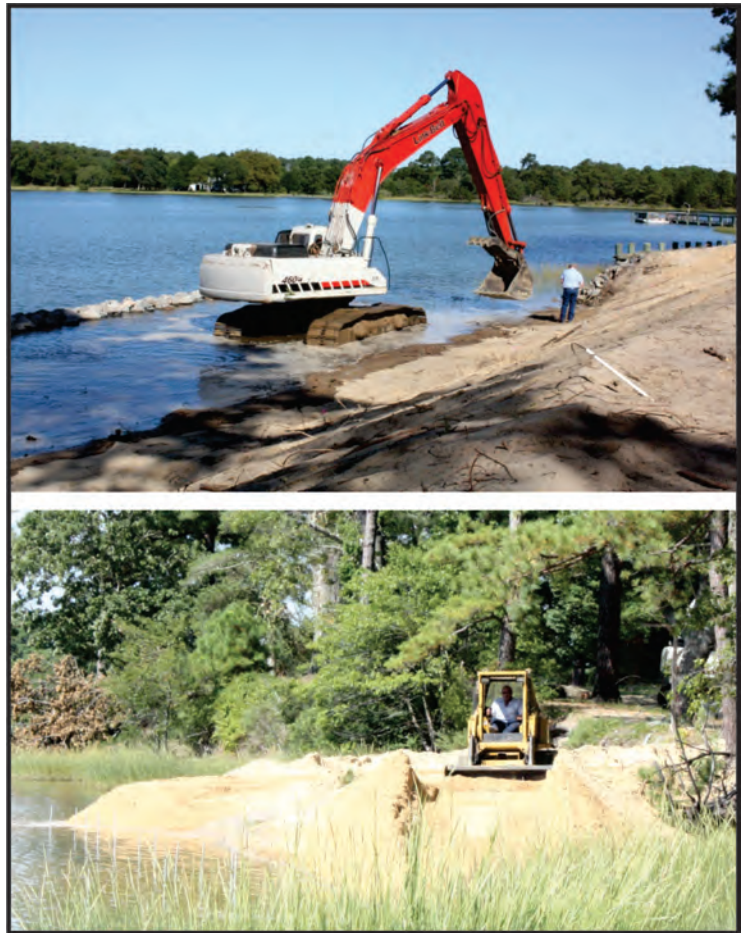
Figure 5-5. Construction of the shore structures at Occohannock on the Bay.

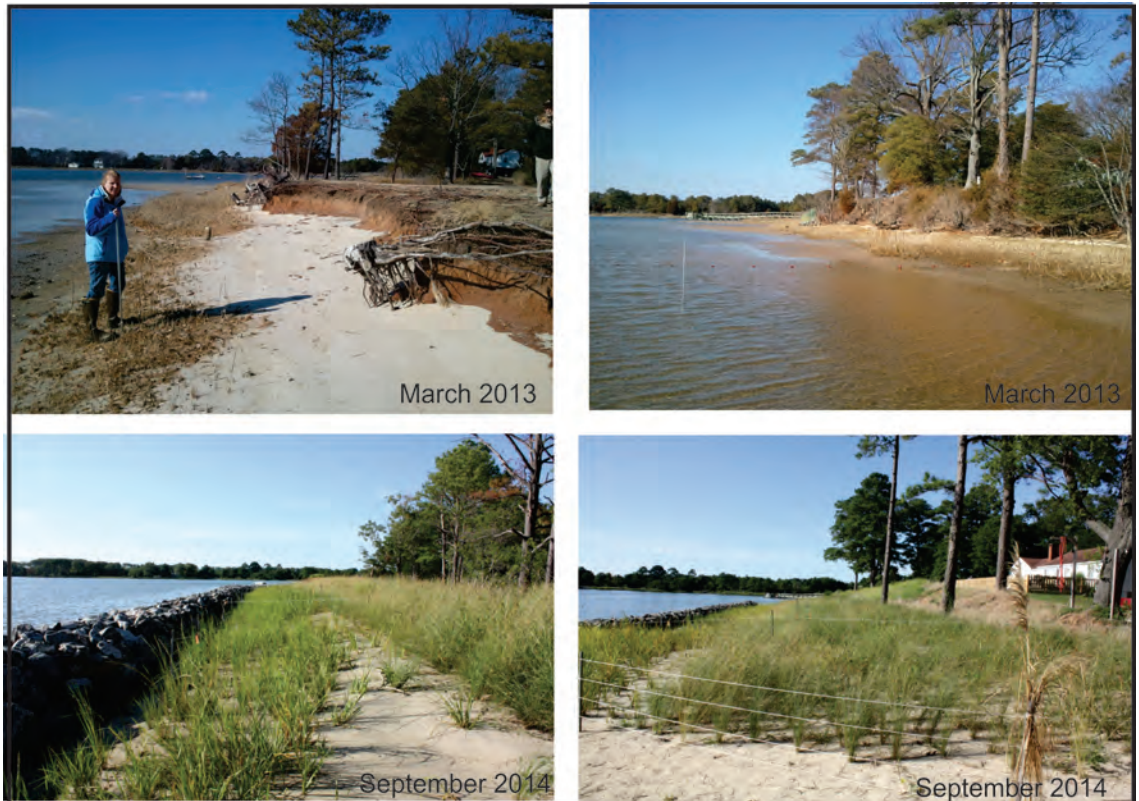
Figure 5-6. Occohannock on the Bay shoreline before (top) sill construction and after (bottom) construction.

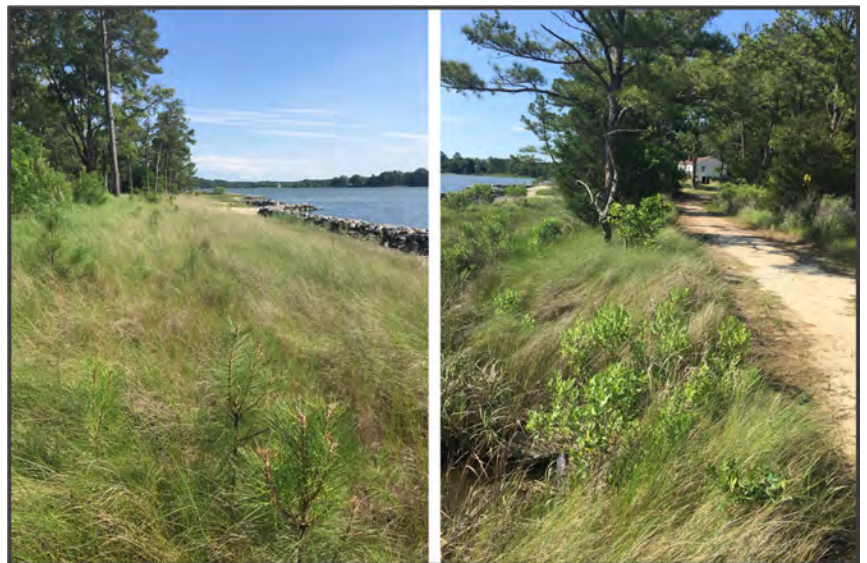
Figure 5-7. Photos of the project three years after installation in May 2017. The marsh behind the sill is expansive (left) and the access road is no longer threatened (right).

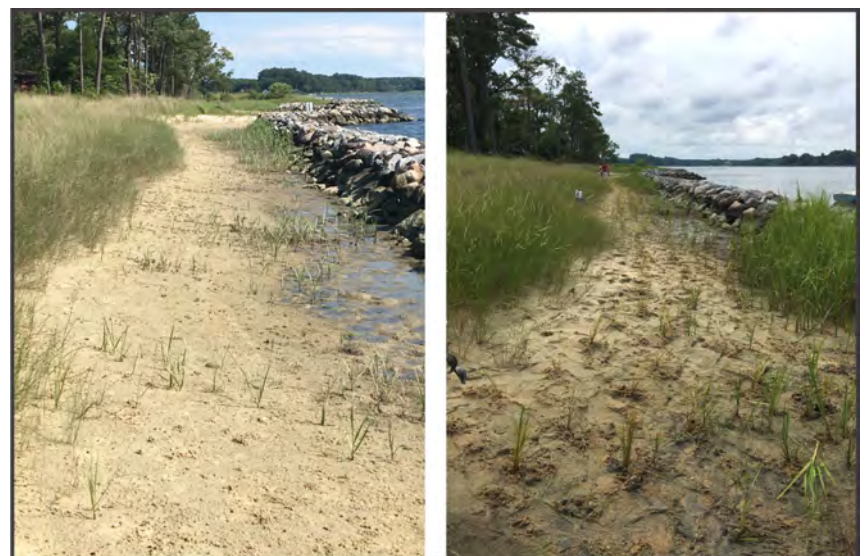
Figure 5-8. Photos showing a bare spot behind the sill (left) in May 2017, and the grasses replanted in July 2017 (right).

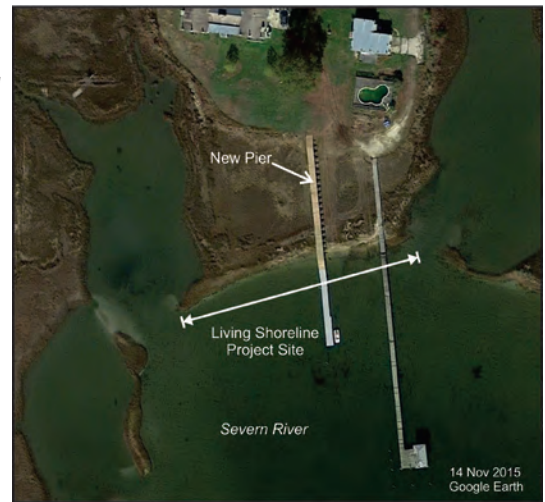
Figure 5-9. Captain Sinclair's Recreational Area pre-construction.

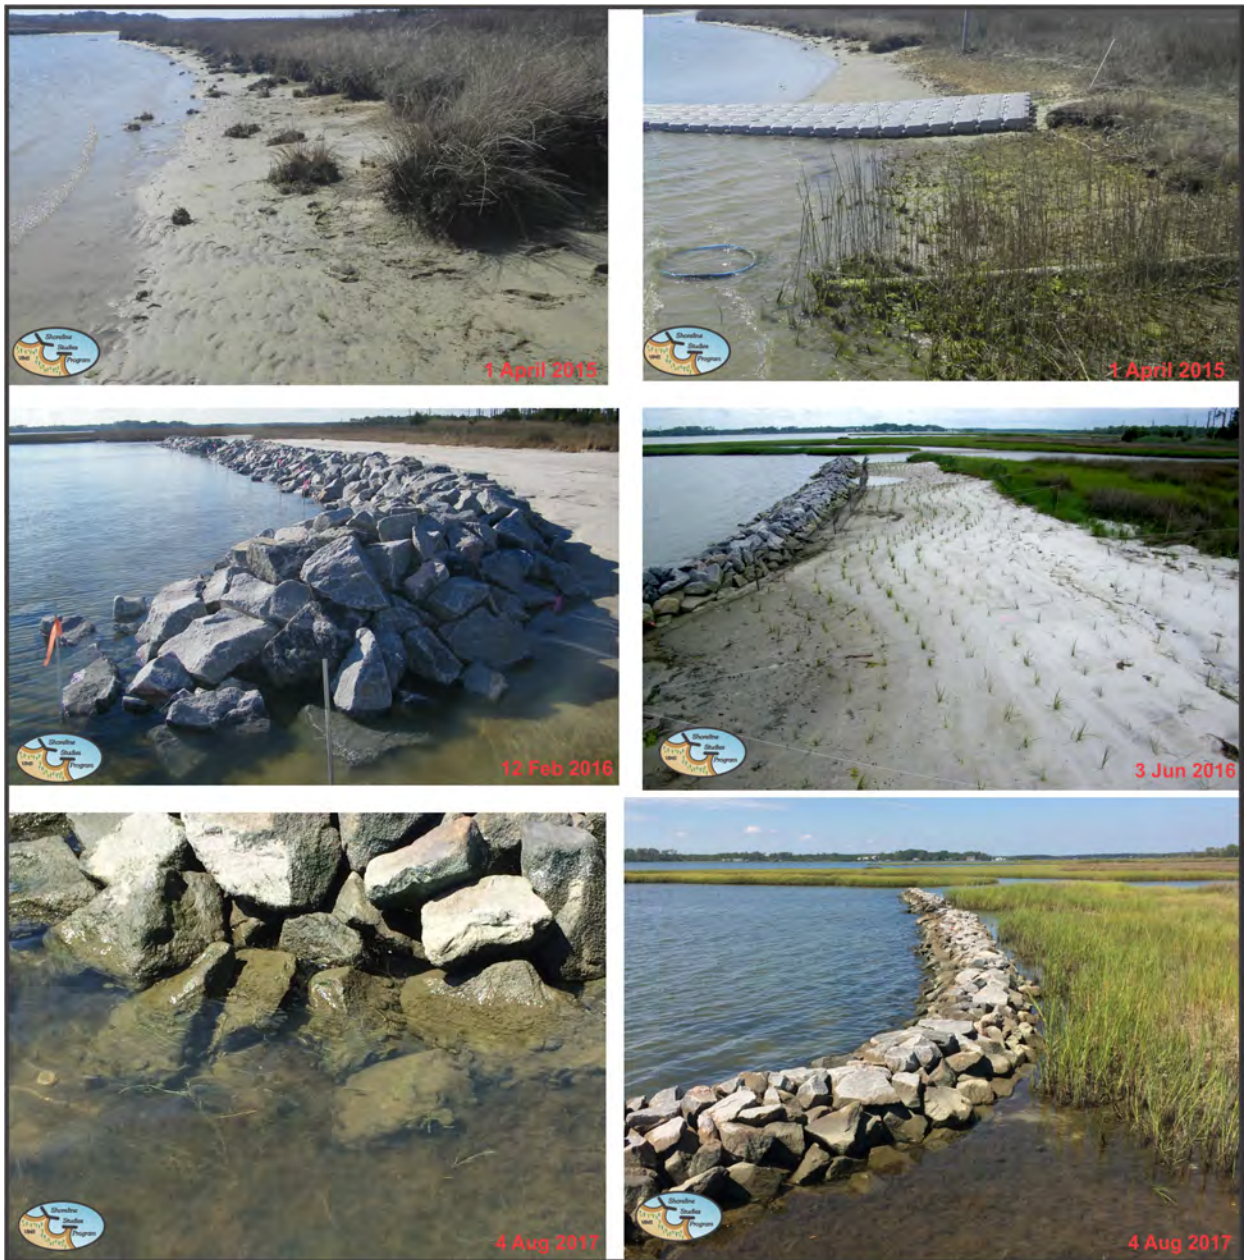
Figure 5-10. Captain Sinclair's Recreational Area pre-construction (top), post-construction (middle), and a year later (bottom). The marsh grasses are lush, SAV has grown behind the structure, and fauna are utilizing the rocks and the marsh.

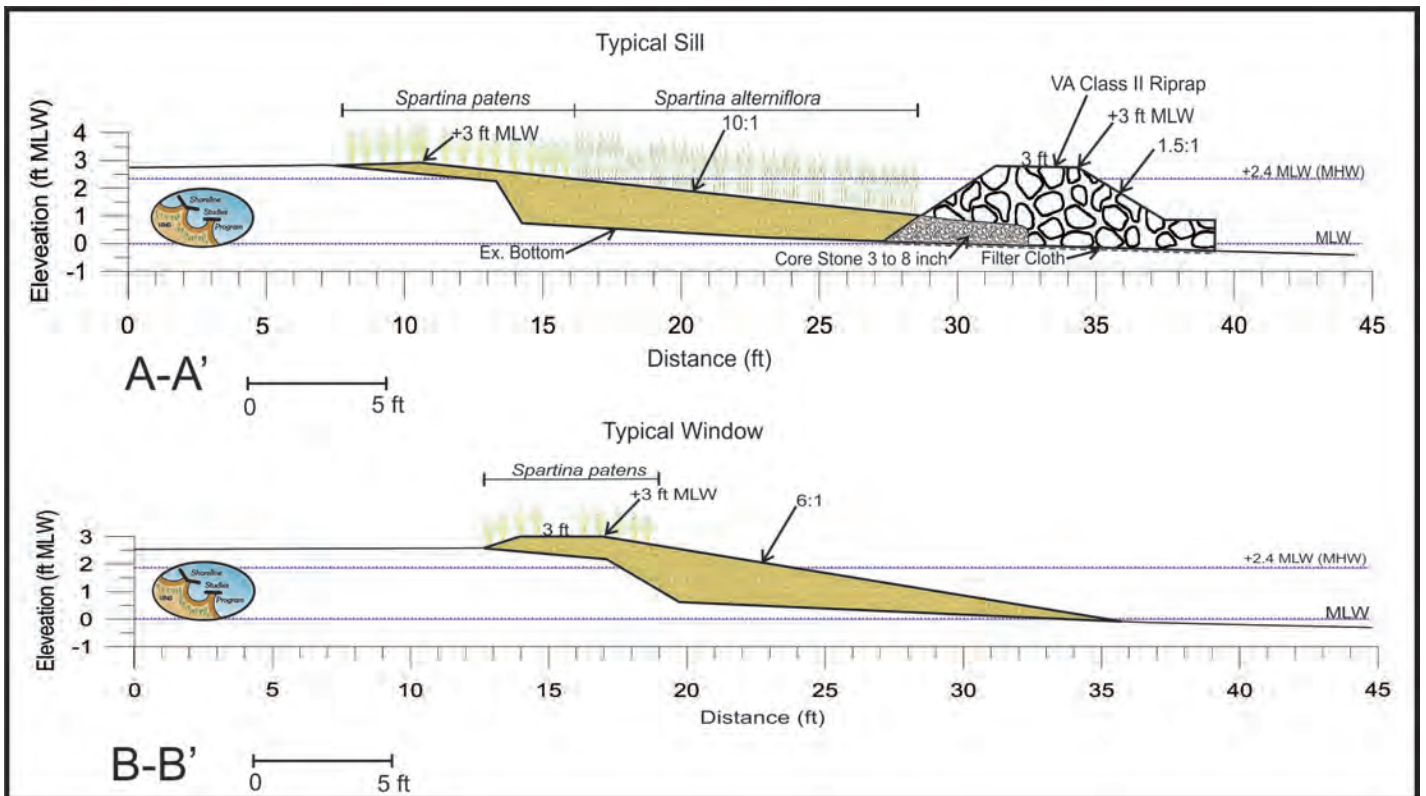
Figure 5-12. Typical cross-section of shore protection structures proposed at Captain Sinclair's Recreational Area.

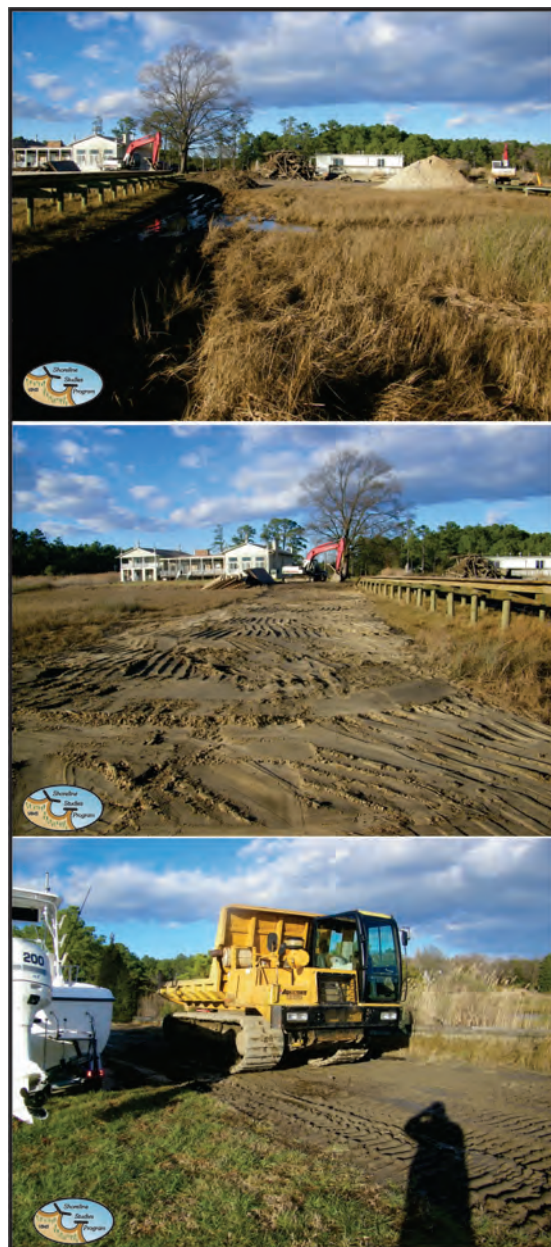
Figure 5-13. Photos taken during construction at Captain Sinclair's Recreational Area on 29 Jan 2016.
